NATIONAL DAM SAFETY PROGRAM. JOHNSON LAKE DAM (MO 106501), MISSO--ETC(U)

JOHNSON LAKE DAM

CARROLL COUNTY, MISSOURI

**PHASE 1 INSPECTION REPORT
NATIONAL DAM SAFETY PROGRAM**

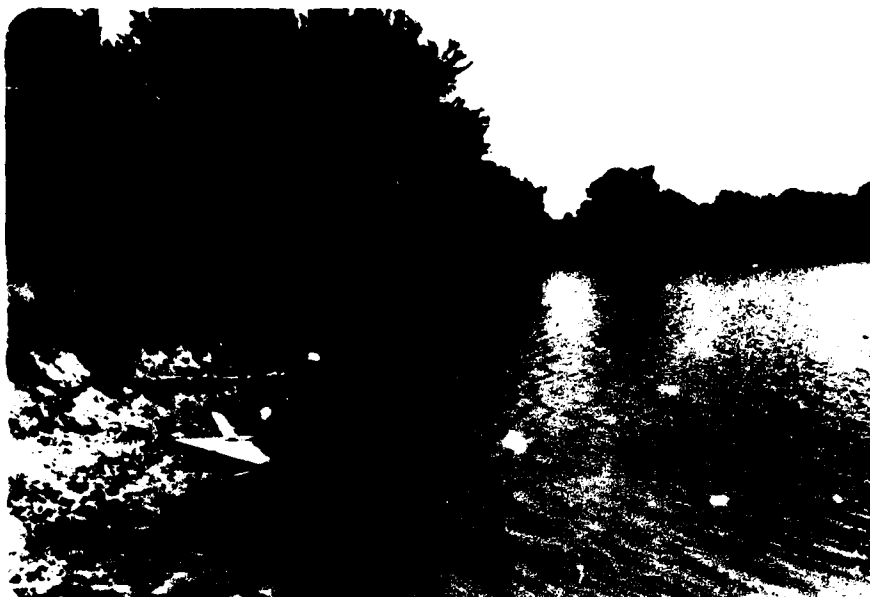
PHOTO NO. 2 - UPSTREAM FACE OF LEFT LEG FROM LEFT END.

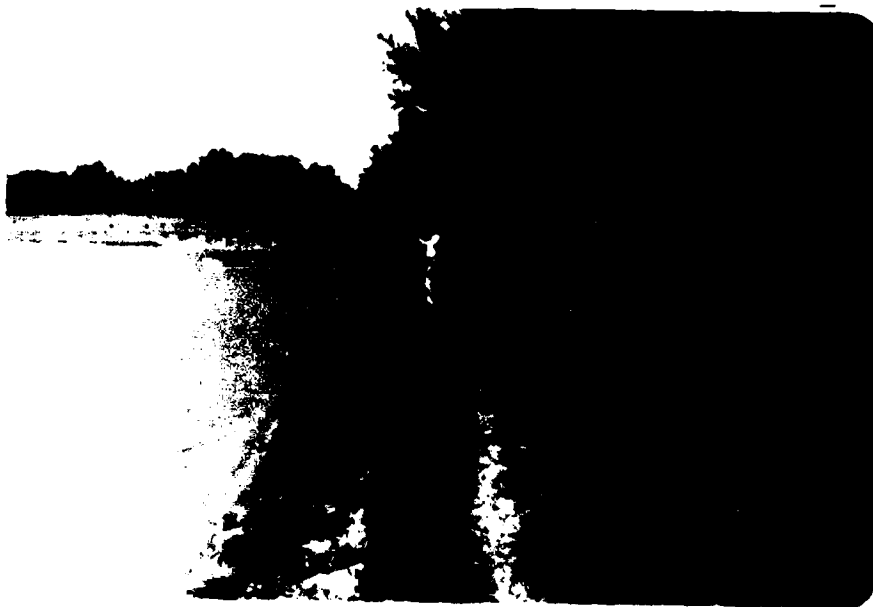
PHOTO NO. 4 - CREST OF LEFT LEG TAKEN FROM RIGHT END.
